VACCO INDUSTRIES  
10350 Vacco Street, South El Monte, CA 91733  
TEL (626) 443-7121 FAX (626) 442-6943  
WEB [www.vacco.com](http://www.vacco.com)

March 14, 2014  
Revised on 8/6/15

In an effort to reduce the risk of rejections for burrs on our hardware and improve our supplier's performance, we are requesting your help. If you are manufacturing any of the below listed hardware we ask that you perform 100% inspection for burrs. The general note on these drawings states to remove all burrs.

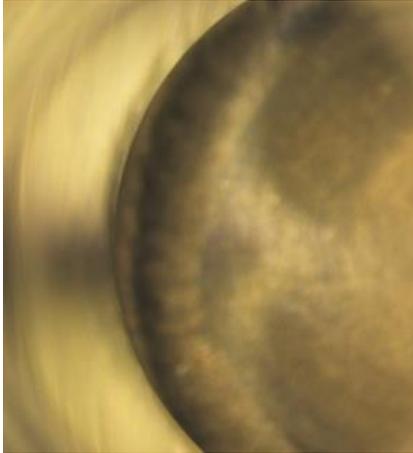
Acceptable Part Example

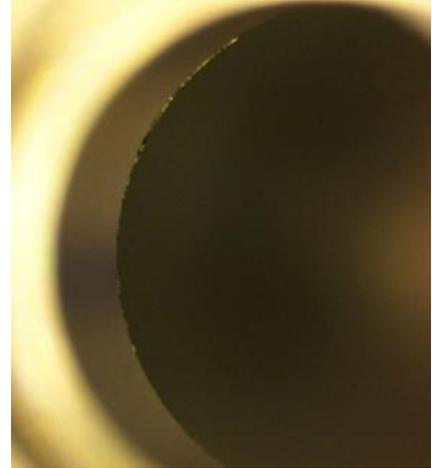
Rejected Part Example

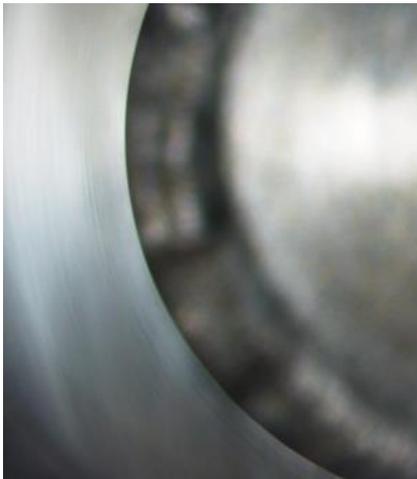
Acceptable Part Example

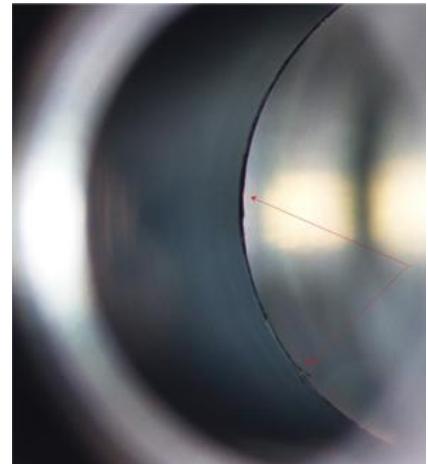
Rejected Part Example

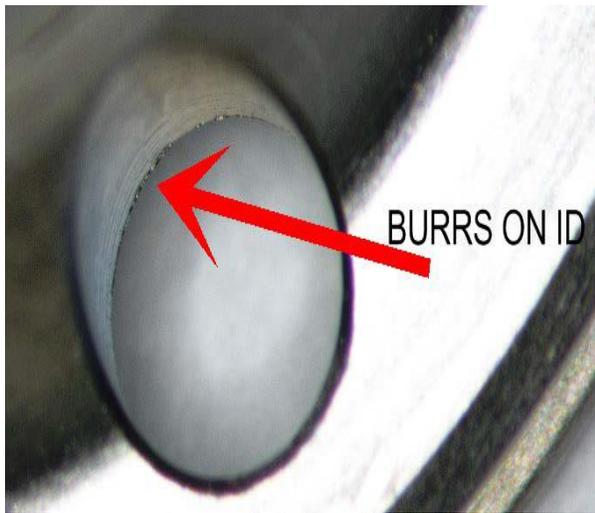
Note: This condition is similar to left over material from weld operations.

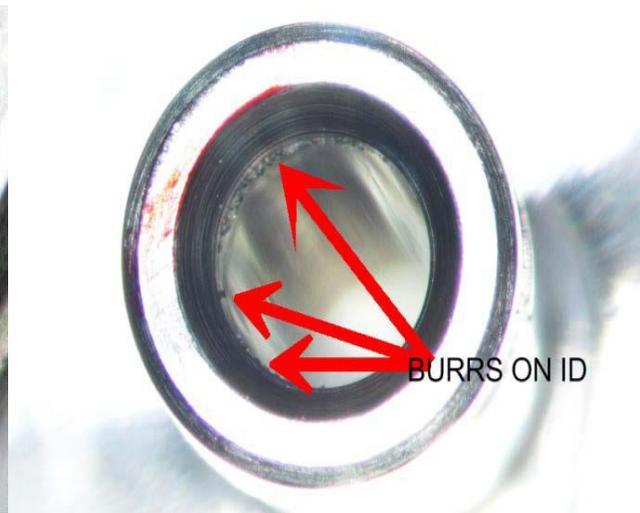
Burrs identified on this location of a part can often be the result of the de-burring process and may be an indication of worn tooling or a process breakdown.
