VACCO INDUSTRIES  
10350 Vacco Street, South El Monte, CA 91733  
TEL (626) 443-7121 FAX (626) 442-6943  
WEB [www.vacco.com](http://www.vacco.com)

March 14, 2014  
Revised on 8/6/15

In an effort to reduce the risk of rejections for burrs on our hardware and improve our supplier's performance, we are requesting your help. If you are manufacturing any of the below listed hardware we ask that you perform 100% inspection for burrs. The general note on these drawings states to remove all burrs.

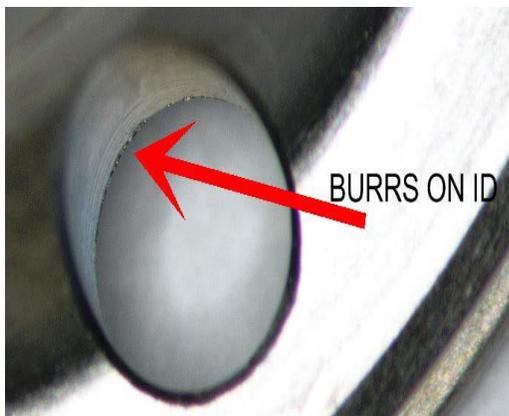
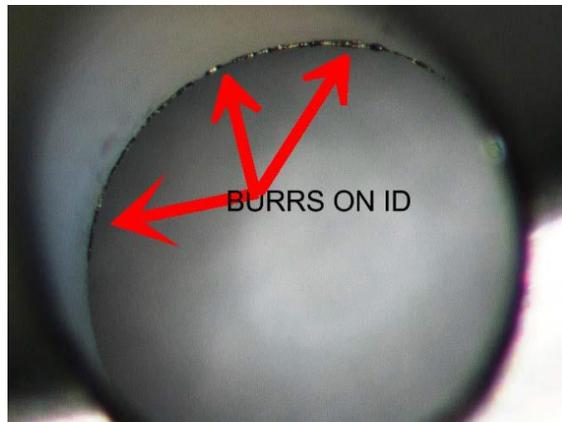
Burrs identified on this location of a part can often be the result of the de-burring process and may be an indication of worn tooling or a process breakdown.
